Technical history of the Willis pipe organ from St George's Church, Charlotte Square, Edinburgh

This technical history of the Willis Pipe organ now in St Mary & St Giles Church, Stony Stratford relates to the period 1882-1965 when the organ was in Edinburgh.

Compiled by John Page based on Kirk Session Records research 2014-2016 and British Organ Archive evidence provided by Chris Kearn in 2012

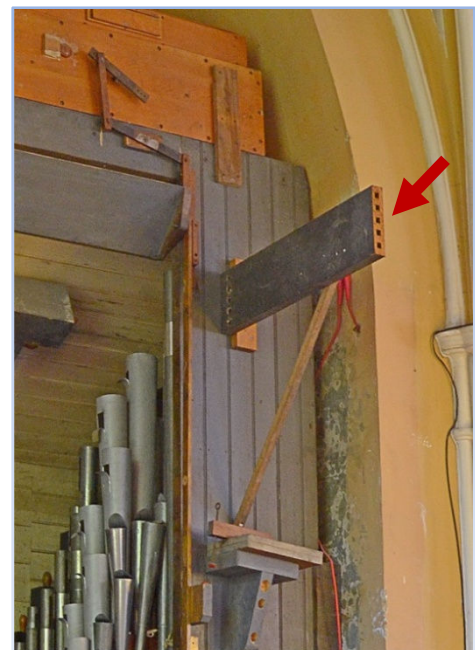
Old discarded boards were cut up and used for stays etc, as the example in the photograph (figure 1) – this one is a stay for the case pipes on the Swell side in SMSG, photo taken during dismantling of the organ for restoration by FH Browne & Sons in July 2014.

Figure 1 photograph of the Willis organ Swell box during dismantling for restoration in 2014, red arrow showing a Willis grooved pedal action board being used as a support stay (photo John Page)

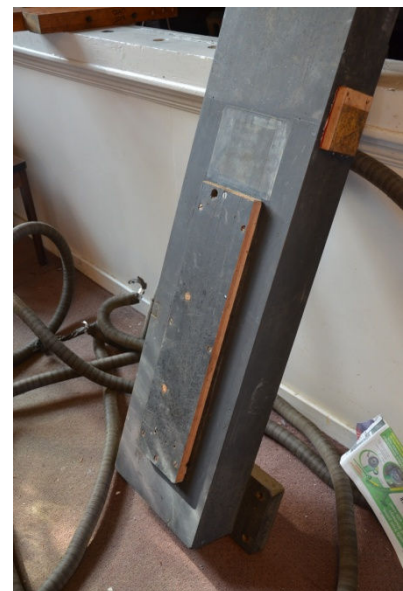
It is also possible that this was the time when "concussion" bellows were fitted to wind trunking. These help steady wind pressures in longer lengths of trunking. The trunking photo (figure 3) shows the Swell low-pressure trunking with a roughly-fitted blanking plate where the concussion bellows would have been. This plate is not to the expected Willis standard, and indicates that the concussion was removed, possibly at the time of installation in the cramped chamber at SMSG by Starmer Shaw organ builders.

Figure 3 Swell low-pressure trunking with a roughly fitted blanking plate where concussion bellows would have fitted (photo John Page)
